**Immediate Response Action
Status Report No. 3** (DEP RTN 3-
23246) **and Immediate Response
Action Status Report No. 1** (DEP
RTN 3-26114)

50 Tufts Street, Somerville, MA

Appendices A through M

May 10, 2007, 2007

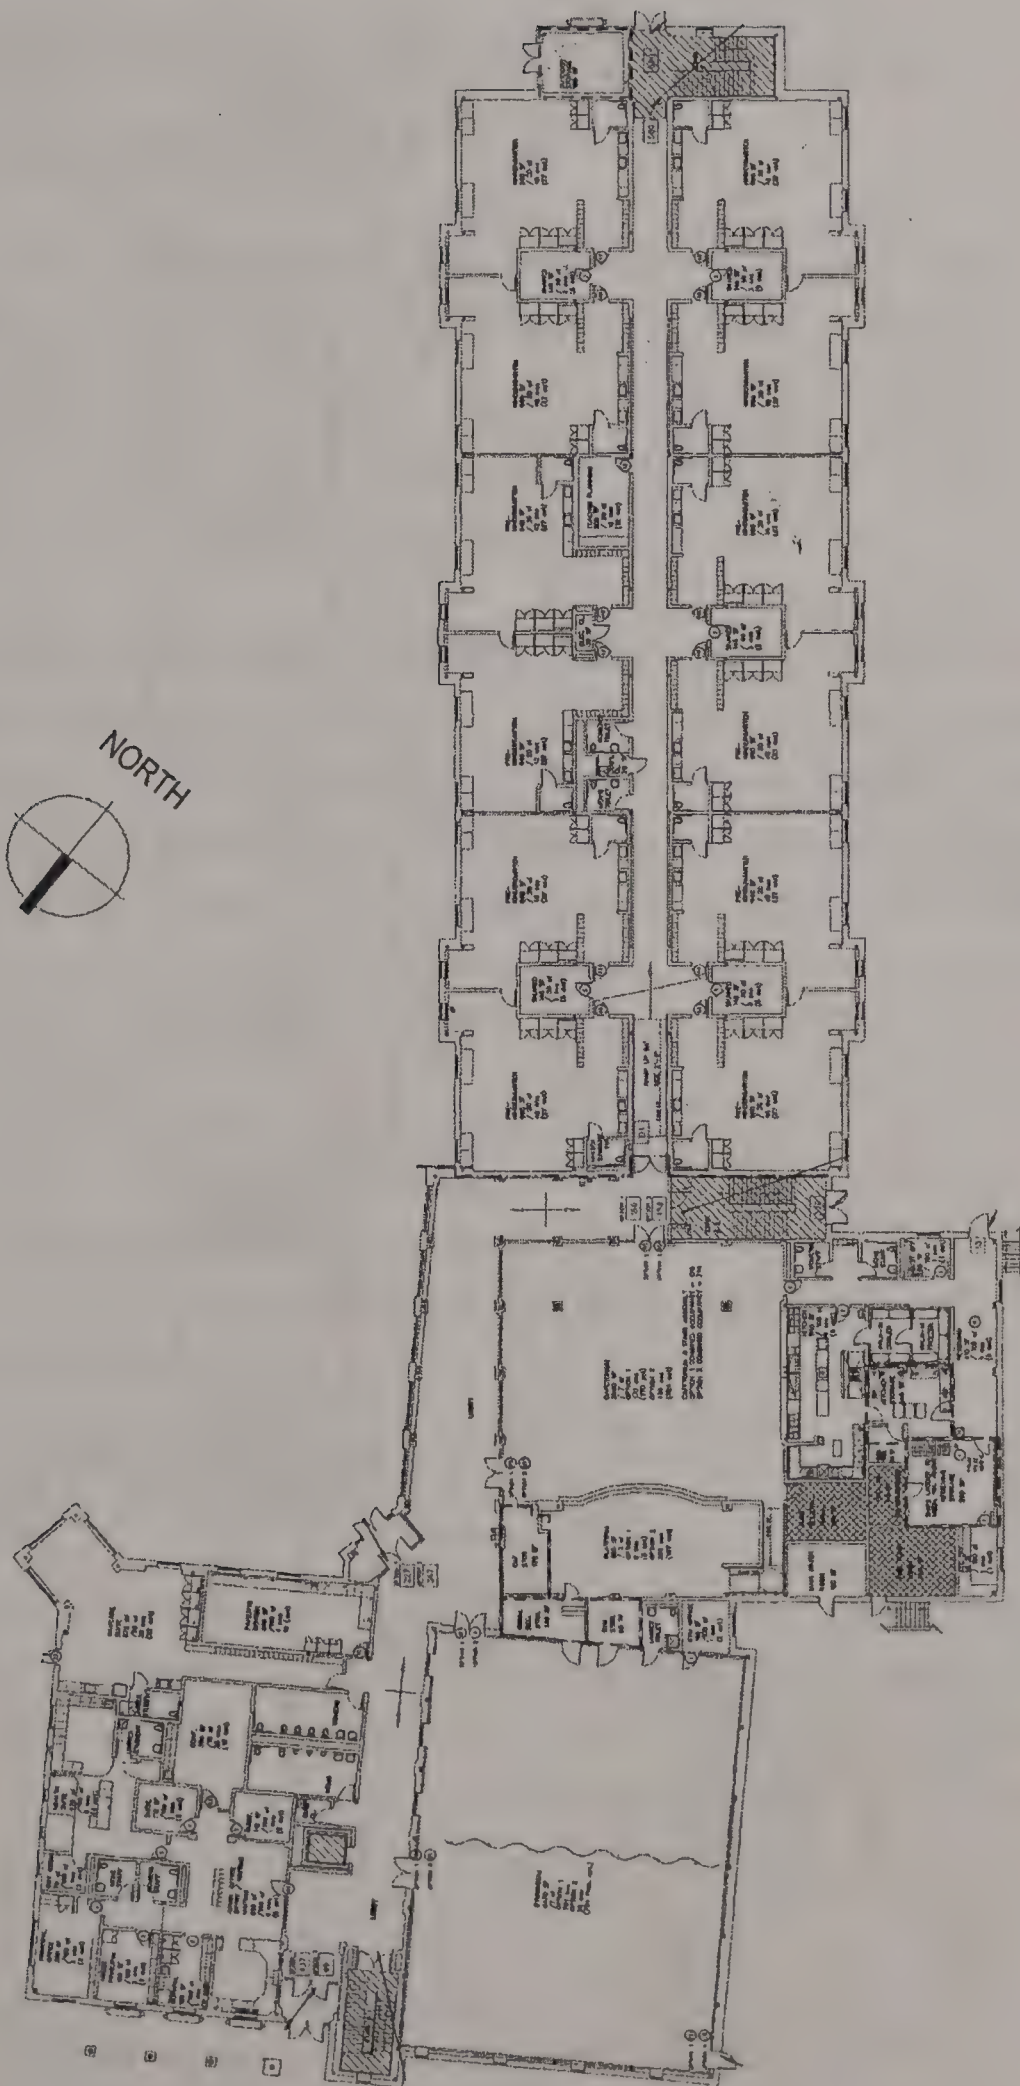
Figure 2.1 First Floor, Capuano Early Childhood Center

The Capuano Early Childhood Center is a two-story slab on grade structure that occupies a footprint of approximately 45,500 square feet. The Center was constructed in 2003 and is divided into two wings, designated on the architectural drawings as the "classroom wing" and the "assembly wing." The classroom wing is on the east side of the building and comprises classroom spaces and work rooms on both the first and second floors. The first floor of the assembly wing is on the building's west side and comprises the cafetorium (cafeteria/auditorium) and kitchen, the gymnasium, administrative offices, and a day care classroom. The second floor includes music and art classrooms, the library/media center, and the computer classroom. A floor plan of the Center is shown in Figures 2.1 and 2.2.

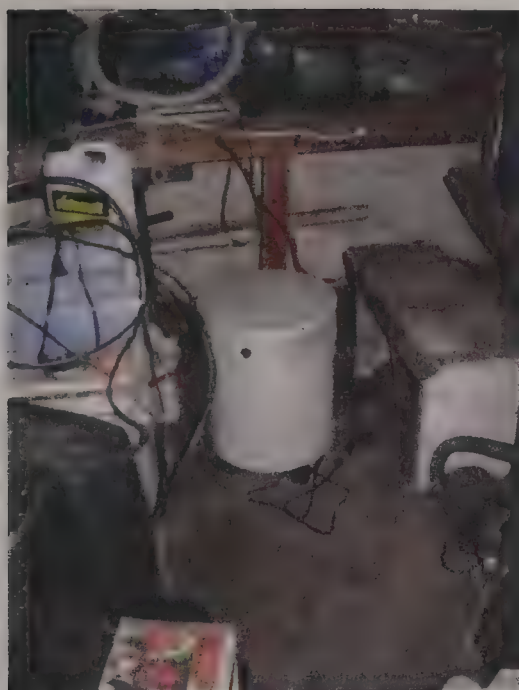
Air Purifiers (Installed on Sample Date)

9 Tufts Street Basement (10/2/2006)

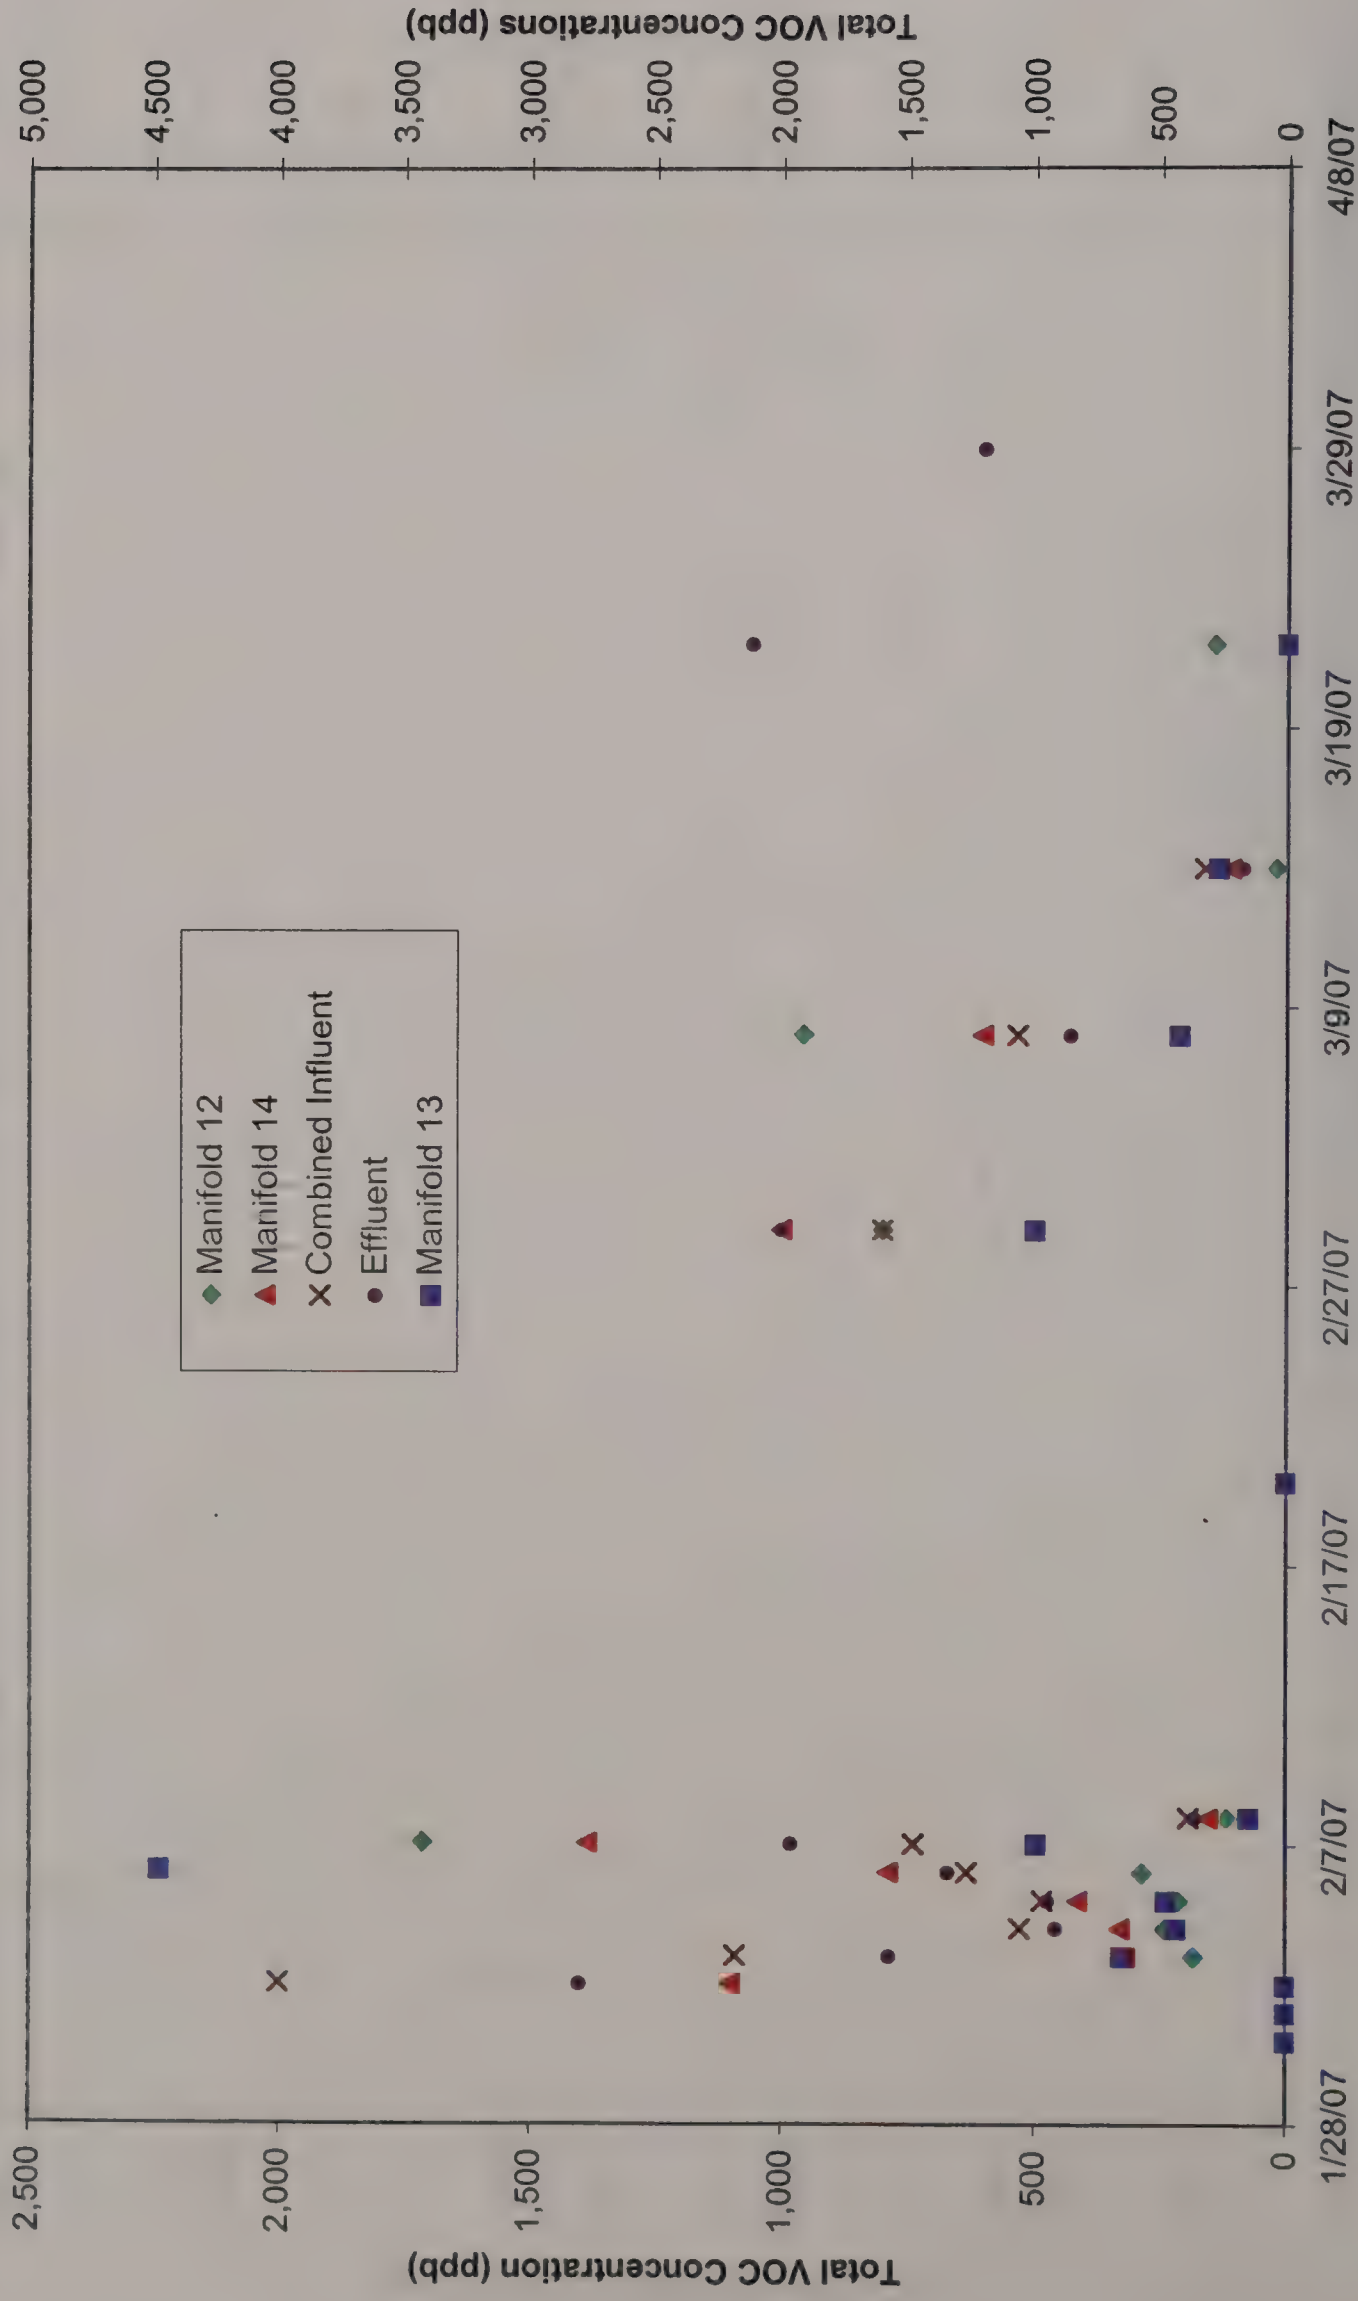
Total VOC Concentrations by PID at Blower Enclosure Monitoring Points Sub-Slab Depressurization System Capuano Early Childhood Center

Note: Total VOC concentrations were measured using a photoionization detector (PID).
Refer to Table 1 for qualifying notes.

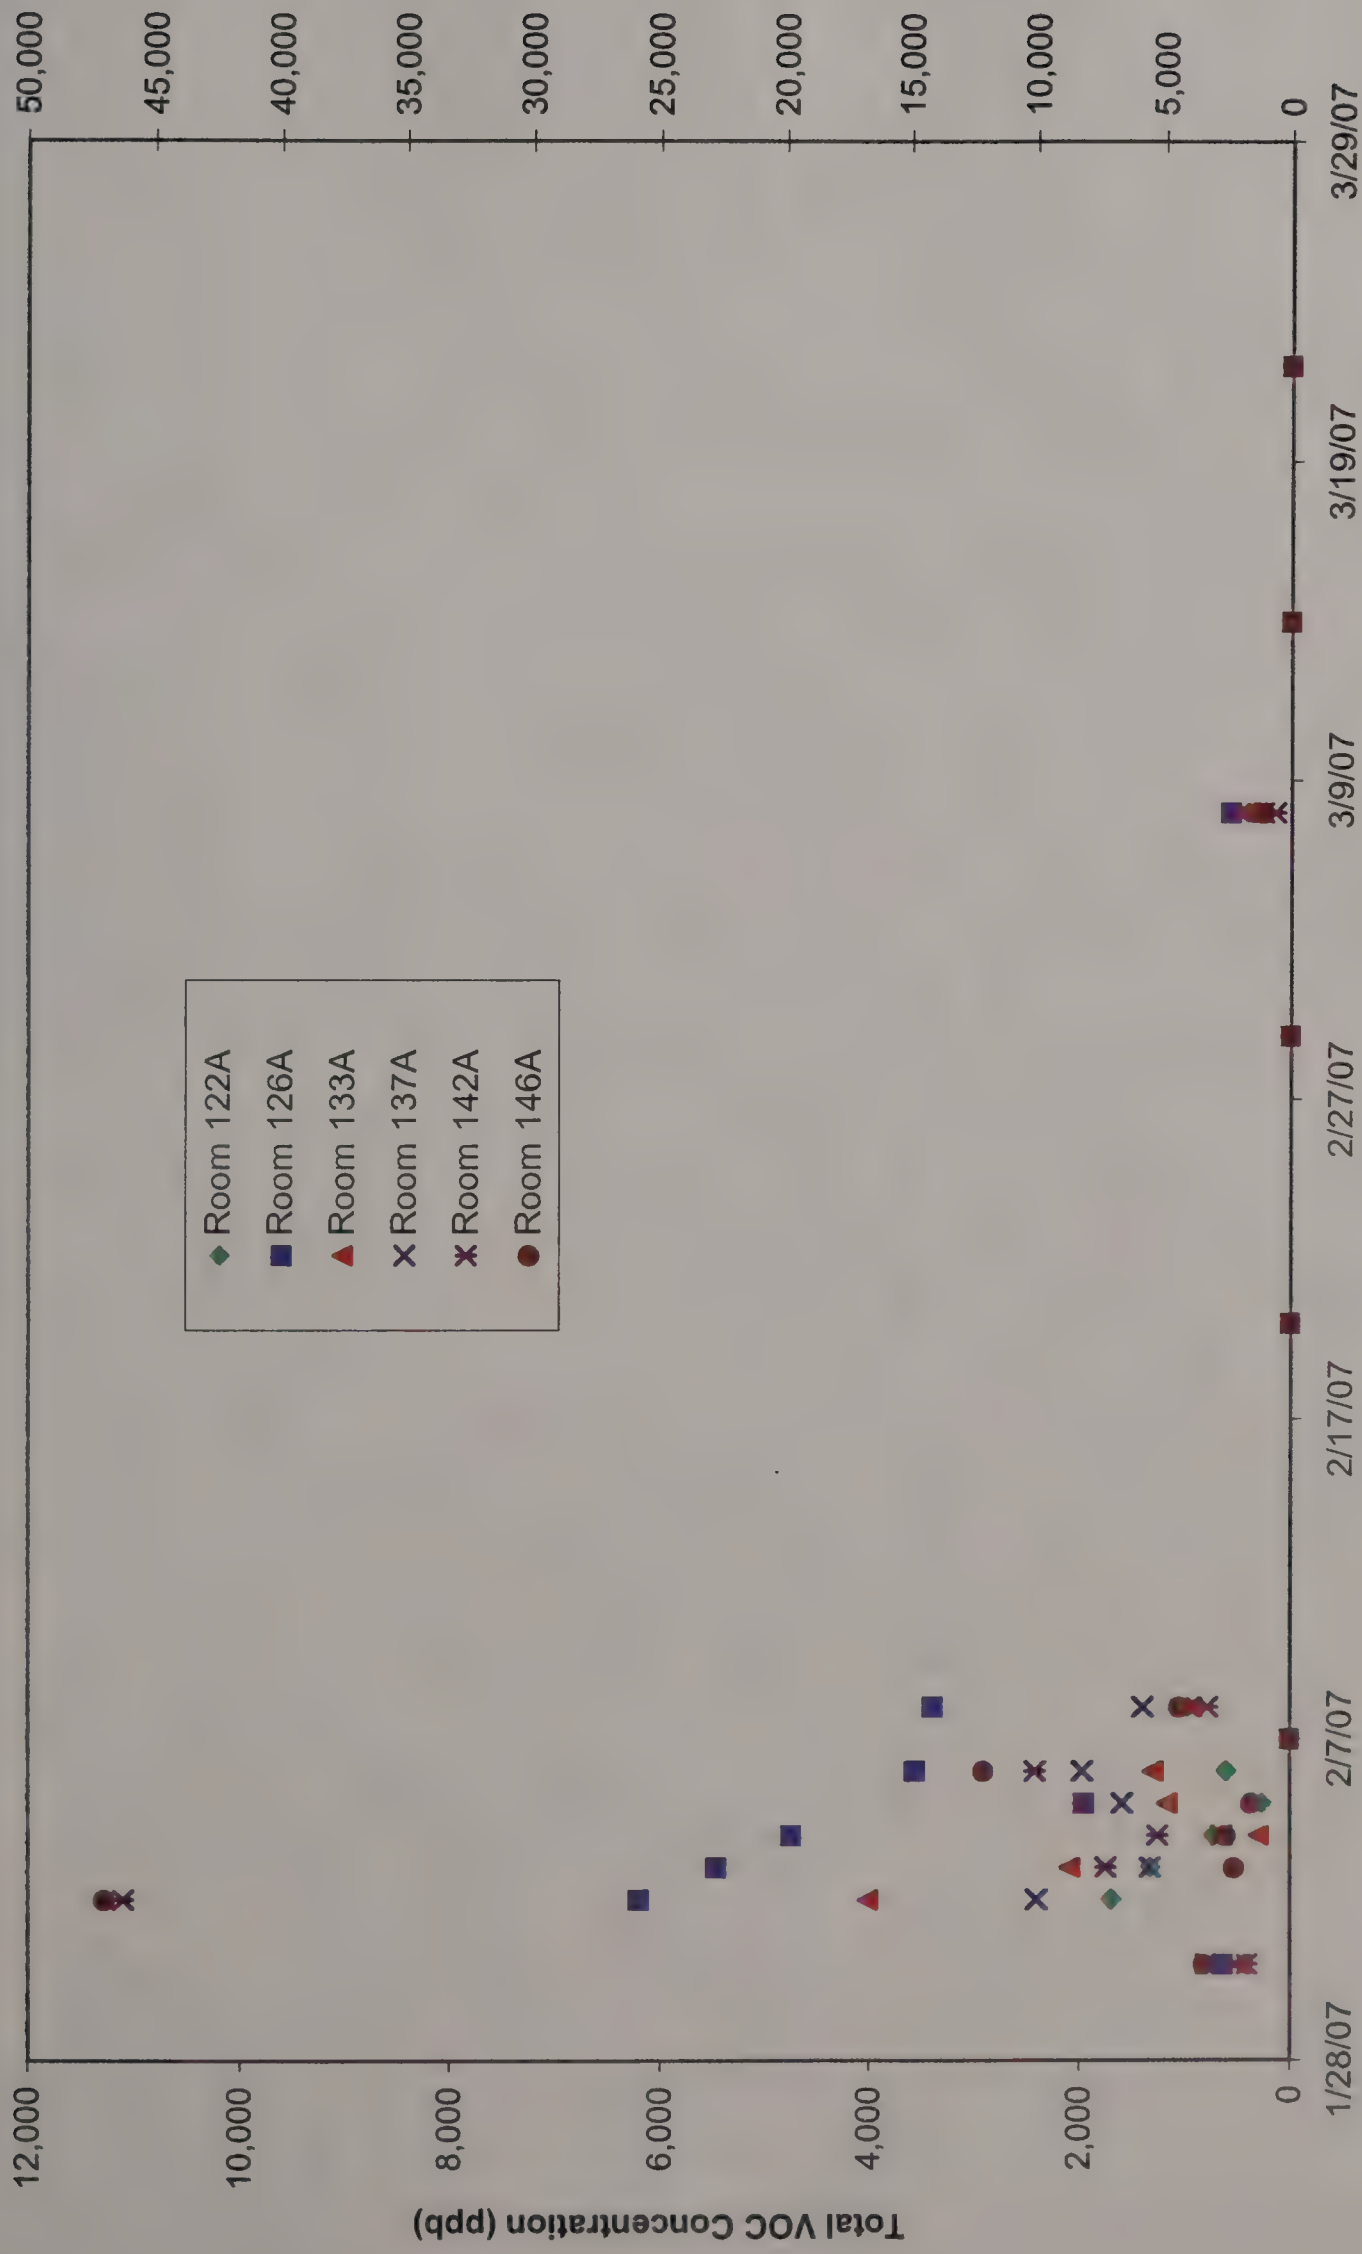
Total VOC Concentrations by PID at Interior Sub-Slab Monitoring Points Sub-Slab Depressurization System Capuano Early Childhood Center

Note: Total VOC concentrations were measured using a photoionization detector (PID).
Refer to Table 1 for qualifying notes.

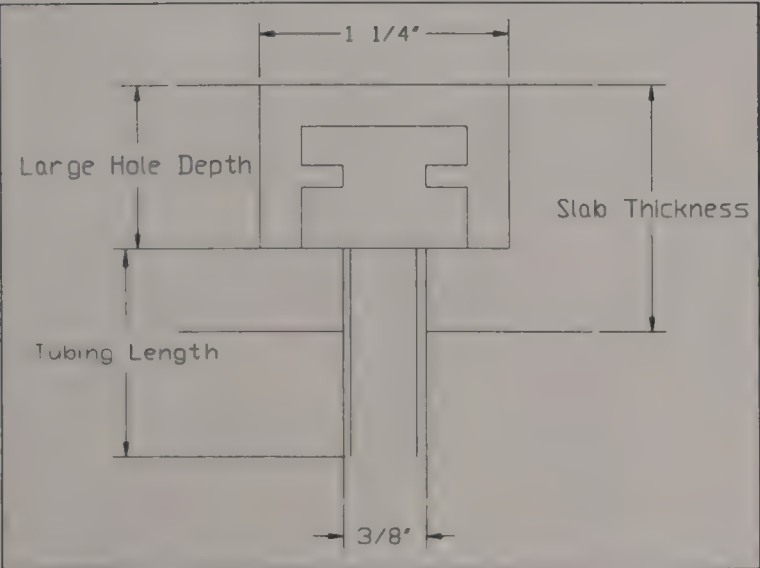
Sub-Slab Monitoring Point Profile

SS1	SS2	SS3	SS4
Slab Thickness:	2.5"			
Tubing Length:	1.75"			
Type of Material Under Slab:	NR			
Large Hole Depth:	2.5"

Comments: Bulkhead entrance, 3 basement windows.
NR = Not recovered

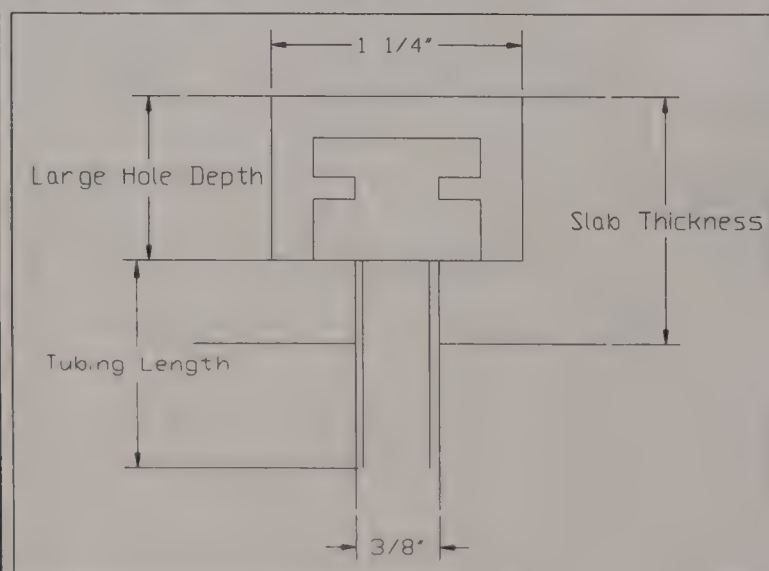
Sub-Slab Monitoring Point Profile

SS1	SS2	SS3	SS4
Slab Thickness:	3"			
Tubing Length:	3"			
Type of Material Under Slab:	Wet sand			
Large Hole Depth:	2"

Comments: **Discovered earlier SS-point had been installed & sampled in Feb. SS2 was filled in with cement. A sampling point was installed in SS1, but not sampled.**

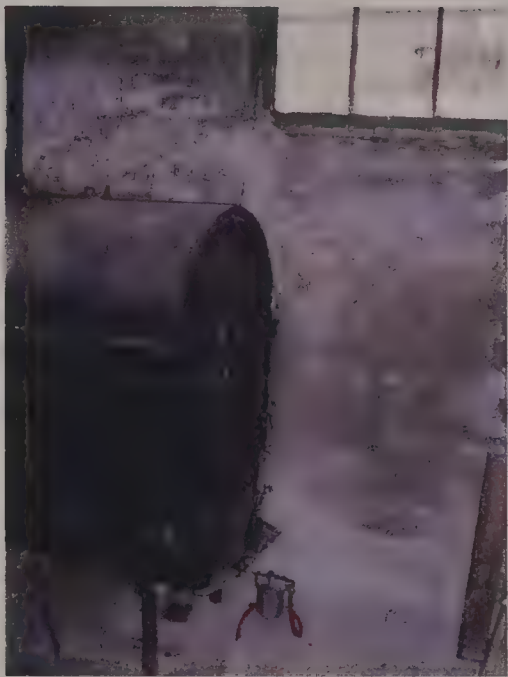
4

Results of screening / comments: electric meters=50ppb, gas=1ppb, above drain= 21ppb. Fuel oil (higher closer to ground): 1=205ppb, 2=354ppb showed signs of leakage, 3=150ppb. Furnace near stairs=~80ppb, furnace at front= ~150ppb, open spaces=0-30ppb.

1. Fuel oil tank partitions along SE wall (February 28, 2007)
2. Fuel oil tank in rearmost partition (March 28, 2007)
3. Fuel oil tank in middle partition (February 28, 2007)
4. Fuel oil tank in front-most partition (March 28, 2007)
5. Furnace and hot water heaters in center front of basement (March 28, 2007)
6. Sump at front of basement (February 28, 2007)
7. Utility meters at front of basement, towards NE corner (March 28, 2007)
8. Electricity meters along NW wall (March 28, 2007)
9. Furnace and hot water heater at rear center of basement (March 28, 2007)
10. Paints and paint thinners on table in front of middle fuel oil tank partition (March 28, 2007)
11. Exterior West Corner (February 28, 2007)
12. Exterior North Corner (February 28, 2007)
13. Summa canister set-up and sampling port for sub-slab soil vapor sample 045162-154Glen-SS1 (February 28, 2007)

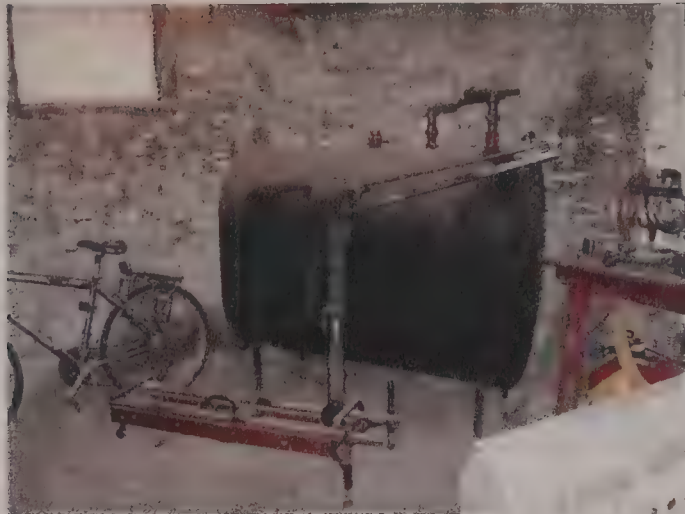
1

1. Fuel oil tank in northwest corner of basement
2. Work bench along northern basement wall
3. Workout area in northeast corner of basement
4. Paint in central area of basement
5. Southeastern basement wall
6. Southern corner of basement
7. Cleaning products in southern corner of basement
8. Southern corner of basement
9. Paint in southern corner of basement
10. Furnaces and hot water heater on southeast wall of the basement
11. Eastern corner of the basement
12. Fire extinguishers and container of fertilizer on ledge next to basement stairs
13. Summa canister set-up and sampling port for sub-slab soil vapor sample: 045162-27Tufts-SS1
14. Summa canister set-up and sampling port for sub-slab soil vapor sample: 045162-27Tufts-SS2

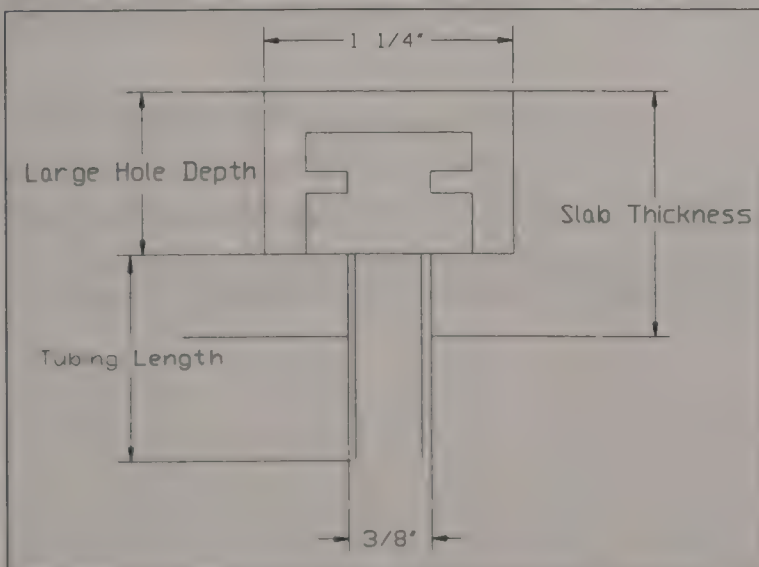
Sub-Slab Monitoring Point Profile

SS1	SS2	SS3	SS4
Slab Thickness:	7' 1/2"	4"	5"	4"
Tubing Length:				
Type of Material Under Slab:	NR	silt	NR	fine sand
Large Hole Depth:	2 1/4"	3 1/2"	2 1/2"	2"

Comments: SS5: 7"; silt & fine sand; 2 1/4"
SS6: 5"; silt & fine sand; 2 1/2"
NR=No recovery

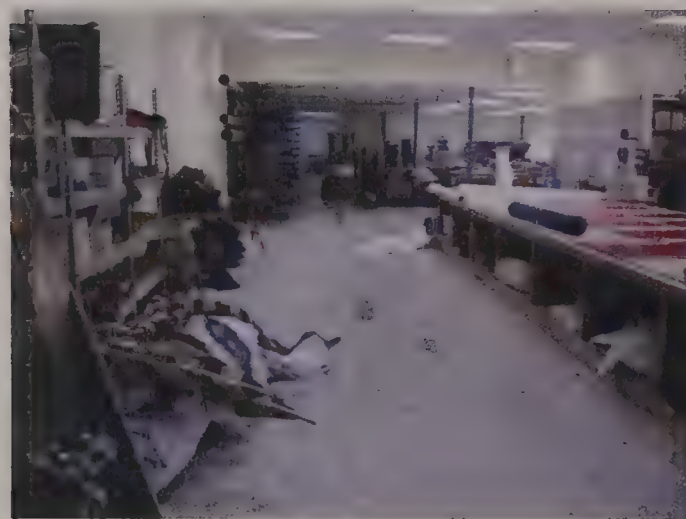
11

10. Southwest corner of "Flagraphics"
11. Southeastern wall of "Flagraphics" and printer room
12. "Flagraphics" sewing machines and staging area
13. View of northwest corner of the building from the northeast
14. Summa canister and sampling port for sub-slab soil vapor sample 045162-40Alston-SS1
15. Summa canister and sampling port for sub-slab soil vapor sample 045162-40Alston-SS2
16. Summa canister and sampling port for sub-slab soil vapor sample 045162-40Alston-SS3
17. Summa canister and sampling port for sub-slab soil vapor sample 045162-30Alston-SS5
18. Summa canister and sampling port for sub-slab soil vapor sample 045162-40Alston-SS6

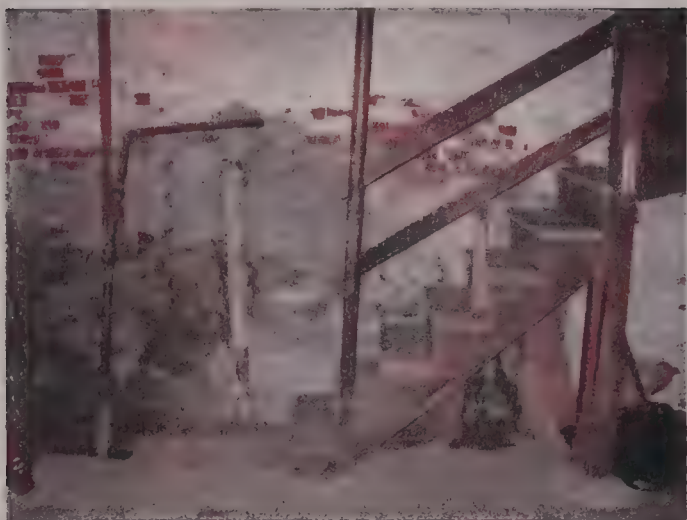
1

1. Stairs along northeastern basement wall
2. Center of the northeastern basement wall
3. East corner of basement
4. South corner of basement
5. View of the furnace and water heater from the northwest
6. Laundry area along the southwestern basement wall
7. Ceiling of southwestern part of the basement
8. Ceiling of the northeastern part of the basement
9. Exterior view of the eastern corner of the residence
10. Exterior view of the southern corner of the residence
11. Exterior view of the western corner of the residence
12. Basement sump pump
13. Summa canister set-up and sampling port for sub-slab soil vapor sample 045162-153Glen-SS1
14. Summa canister set-up and sampling port of sub-slab soil vapor sample 045162-153Glen-SS2.

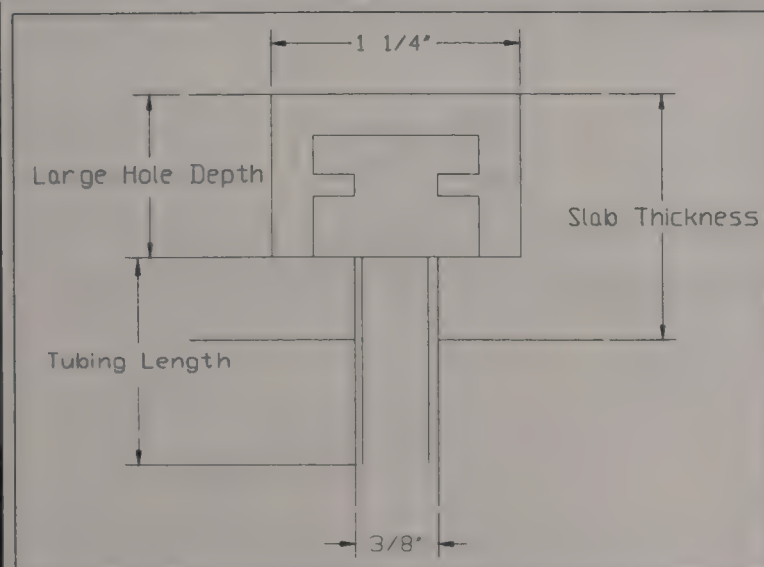
Sub-Slab Monitoring Point Profile

SS1	SS2	SS3	SS4
Slab Thickness:	1"	1 3/4"		
Tubing Length:	1"	3/4"		
Type of Material Under Slab:	sandy silt	fine sand		
Large Hole Depth:	1 1/2"	1 3/4"

Comments: Removed and reinstalled previous points in same locations. Soil was wet under SS1A.

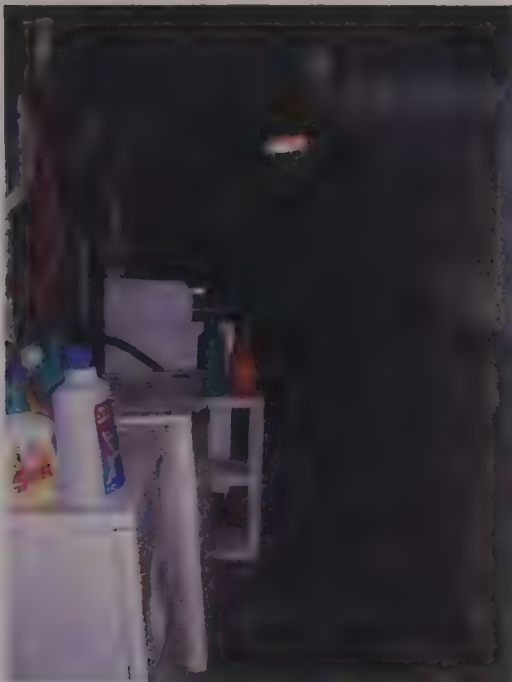
1

1. Laundry detergents, washer and dryer along northeast wall of basement
2. Water heaters and brick repair on northern corner walls
3. Brick/stone interface in western corner of foundation wall
4. Furnaces in central area of basement surrounded by wood-frame and dry-wall partitioning
5. Storage closet items
6. Old stove along southeastern wall
7. Open space behind partitioning in southern corner of basement
8. Utility meters along the northwestern wall
9. Summa canister and sampling port for sub-slab soil vapor sample 045162-21Mort-SS1
10. Summa canister and sampling port for sub-slab soil vapor sample 045162-21Mort-SS1A (reinstallation of SS1 on 3/28/07)
11. Summa canister and sampling port for sub-slab soil vapor sample 045162-21Mort-SS2A (reinstallation of SS2 on 3/28/07)

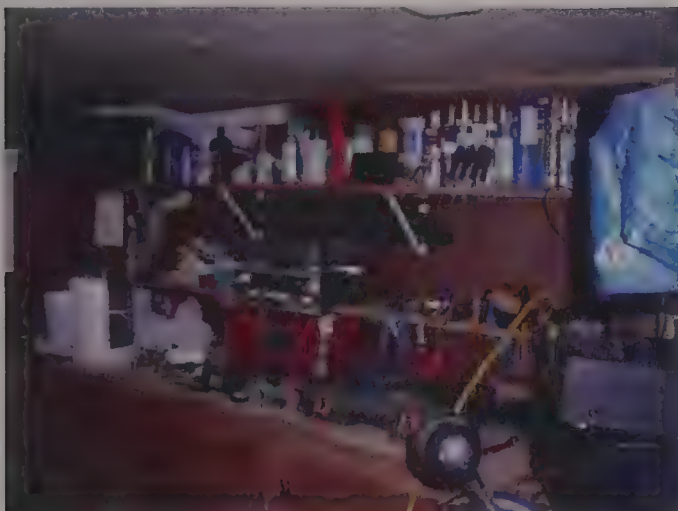
1

1. Workbench in southwest corner
2. Workbench in southwest corner with insulated piping in foreground
3. Paints, finishes, etc. on utility shelving along northwest wall
4. Box of empty motor oil containers against southwestern wall at base of stairs
5. View of water heater, washer/dryer, storage items along northwestern wall from the south
6. Furnace in southeastern alcove
7. Furnace in central area of basement
8. Office area in the southeast corner of basement
9. Utility meters along the northeastern basement wall
10. Sampling port for sub-slab soil vapor sample 045162-18Mort-SS2
11. Hole in concrete slab surrounding water meter along the northeastern basement wall
12. Sampling port for sub-slab soil vapor sample 045162-18Mort-SS2
13. Summa canister set-up for sub-slab soil vapor sample 045162-18Mort-SS1
14. Summa canister set-up for sub-slab soil vapor sample 045162-18Mort-SS2

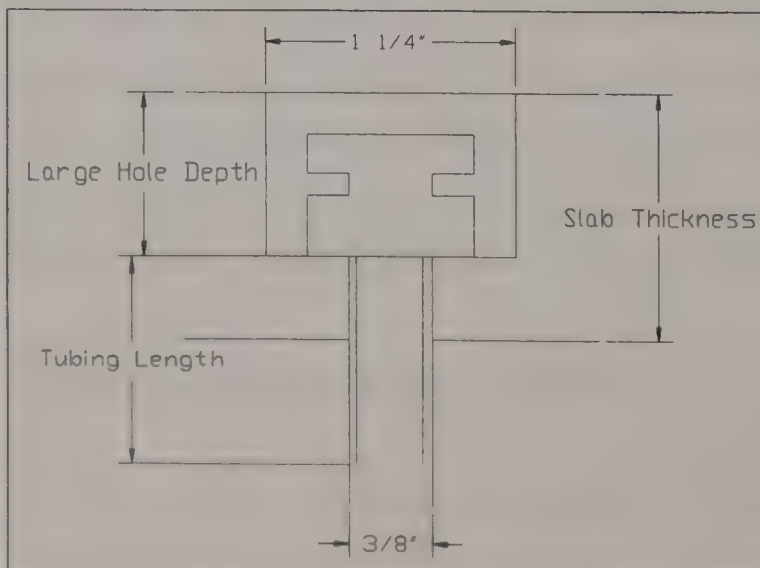
Sub-Slab Monitoring Point Profile

SS1	SS2	SS3	SS4
Slab Thickness:	4"	1 1/2"		
Tubing Length:	4 1/8"	6 1/2"		
Type of Material Under Slab:	NR	NR		
Large Hole Depth:	1 3/4"	2 1/2"

Comments: Gravel in SS2 caused drill bit to deflect from vertical during point installation.
 NR = Not recovered

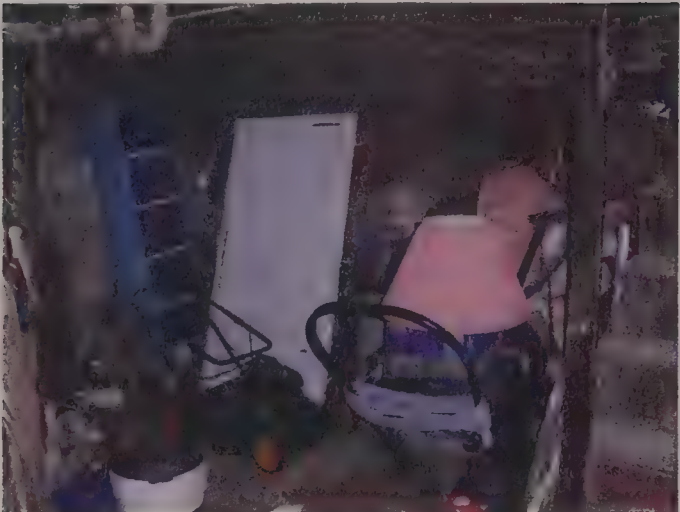
1

1. Southern corner of basement (view of beneath the stairs).
2. Looking WNW down basement from west near the stairs.
3. View of Eastern corner of basement from the west.
4. Furnace and water heaters along northern wall.
5. Paints, primers and miscellaneous storage items in the western half of the basement.
6. Paints, primers and miscellaneous storage items in the western half of the basement.
7. Furniture stored along northern area of basement near the stairs.
8. Storage items and electric meters along western wall.
9. Gas meters on eastern wall.
10. Summa canister and sub-slab soil vapor sampling port for sample 045162-35Know-SS1.
11. Summa canister and sub-slab soil vapor sampling port for sample 045162-35Know-SS2.

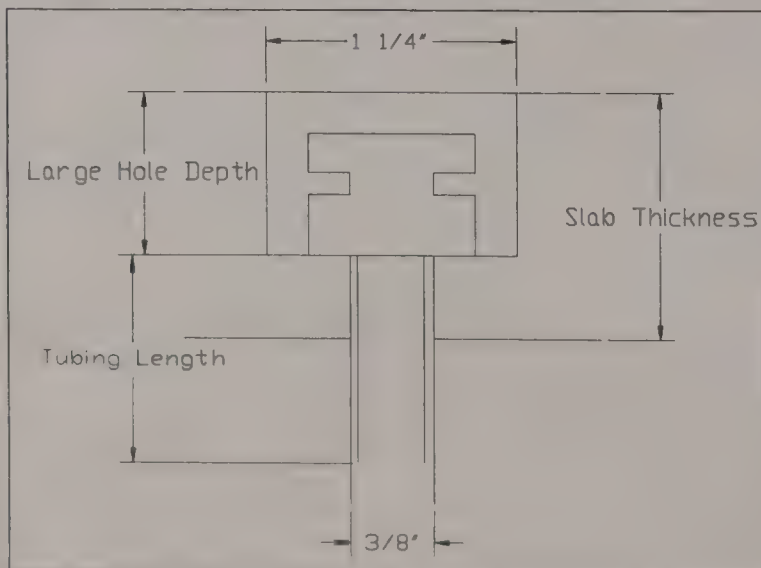
Sub-Slab Monitoring Point Profile

SS1	SS2	SS3	SS4
Slab Thickness:	NA	NA		
Tubing Length:	3.5'	3.5'		
Type of Material Under Slab:	silt	silt		
Large Hole Depth:	2.5'	2.5'

Comments: soil slightly damp towards bottom
 8 windows in basement, walls unsealed; Both holes were 2.5' deep and packed with 1' sand, 1' bentonite, and .5' sand. Topped with a concrete seal

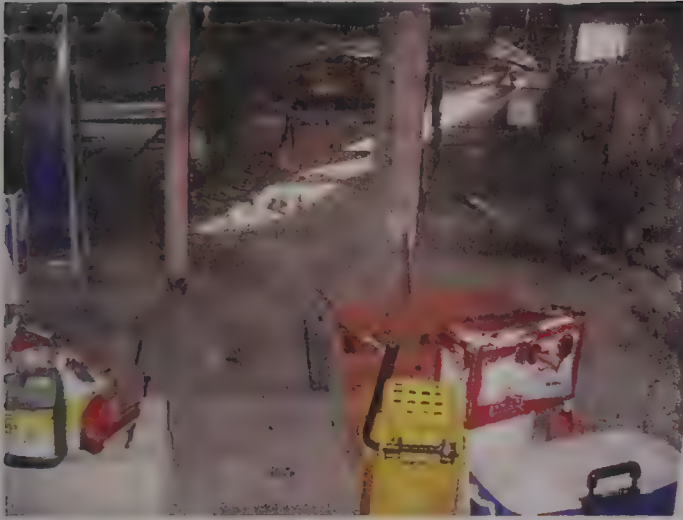
1

1. Northeast corner of basement.
2. View of northwest corner of basement from the northeast.
3. Southeast corner of basement.
4. Southwest corner of basement.
5. Northwest corner of basement.
6. Paints and cleaning supplies.
7. Paints and cleaning supplies.
8. Paints and cleaning supplies.
9. Exterior view of northeast corner of residence.
10. Exterior view of southeast corner of residence.
11. Basement ceiling in northern half of the basement.
12. Basement ceiling in southern half of the basement
13. Summa canister setup and soil gas sampling point for sample 045162-91Frank-SG1A.
14. Summa canister setup and soil gas sampling point for sample 045162-91Frank-SG2.

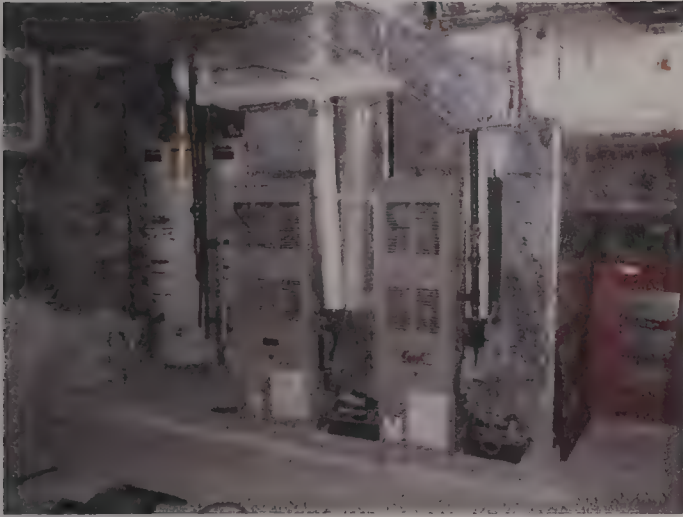
1

1. Furnaces and water heaters in the northern corner of the basement
2. Eastern corner of the basement
3. Eastern corner of the basement
4. Eastern side of the basement
5. Northern corner of the basement
6. Laundry area in northern corner of the basement
7. Exterior view of the western side of the residence from the north
8. Exterior view of the eastern side of the residence from the north
9. Exterior view of the eastern side of the residence from the south
10. Summa canister set-up and sampling port for sub-slab soil vapor sample 045162-11Mort-SS1
11. Summa canister set-up and sampling port for sub-slab soil vapor sample 045162-11Mort-SS2

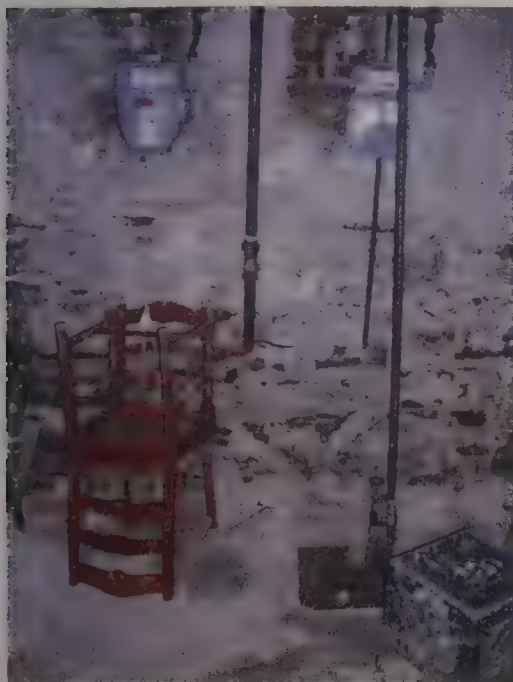
1

1. Utility meters on western basement wall.
2. Furnace and shelving in southwest corner of basement.
3. Hot water heater and shelving along eastern wall in southeast corner of basement.
4. Miscellaneous items on shelves at basement entrance.
5. Household cleaning and maintenance products on shelves at basement entrance.
6. Miscellaneous items on shelves at basement entrance.
7. Electricity meters and kiln in northwest corner of basement near slab-dirt boundary in floor.
8. Hot water heater along northeast corner of basement.
9. Shelving along southern wall of basement.
10. Workbench in center of slab portion of basement.
11. Summa canister setup and sub-slab soil vapor sampling port for sample 045162-29KNOW-SS1.
12. Summa canister setup and sub-slab soil vapor sampling port for sample 045162-29KNOW-SS1.

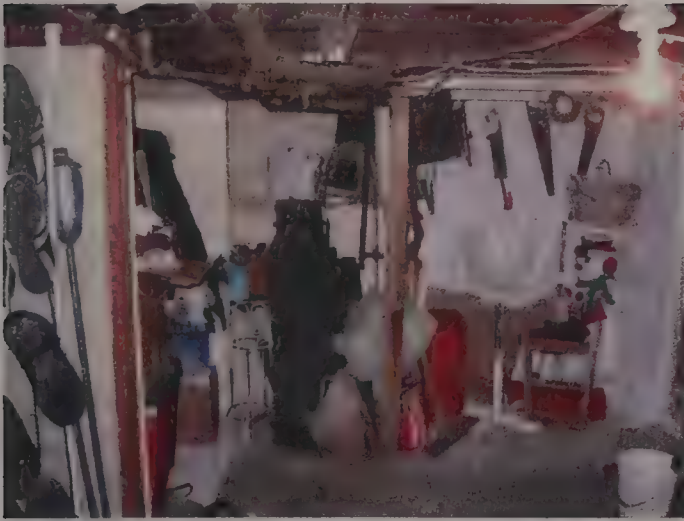
1

1. Western room of basement.
2. Detergents along northern wall next to washer and dryer.
3. Water heater in the center of basement.
4. Utility meter on east wall of basement near the base of stairs.
5. Washer and dryer along northern wall of basement.
6. Furnace in center of basement.
7. Summa canister setup and sub-slab soil vapor sampling port for sample 045162-82FRANK-SS1.
8. Summa canister setup and sub-slab soil vapor sampling port for sample 045162-82FRANK-SS1.

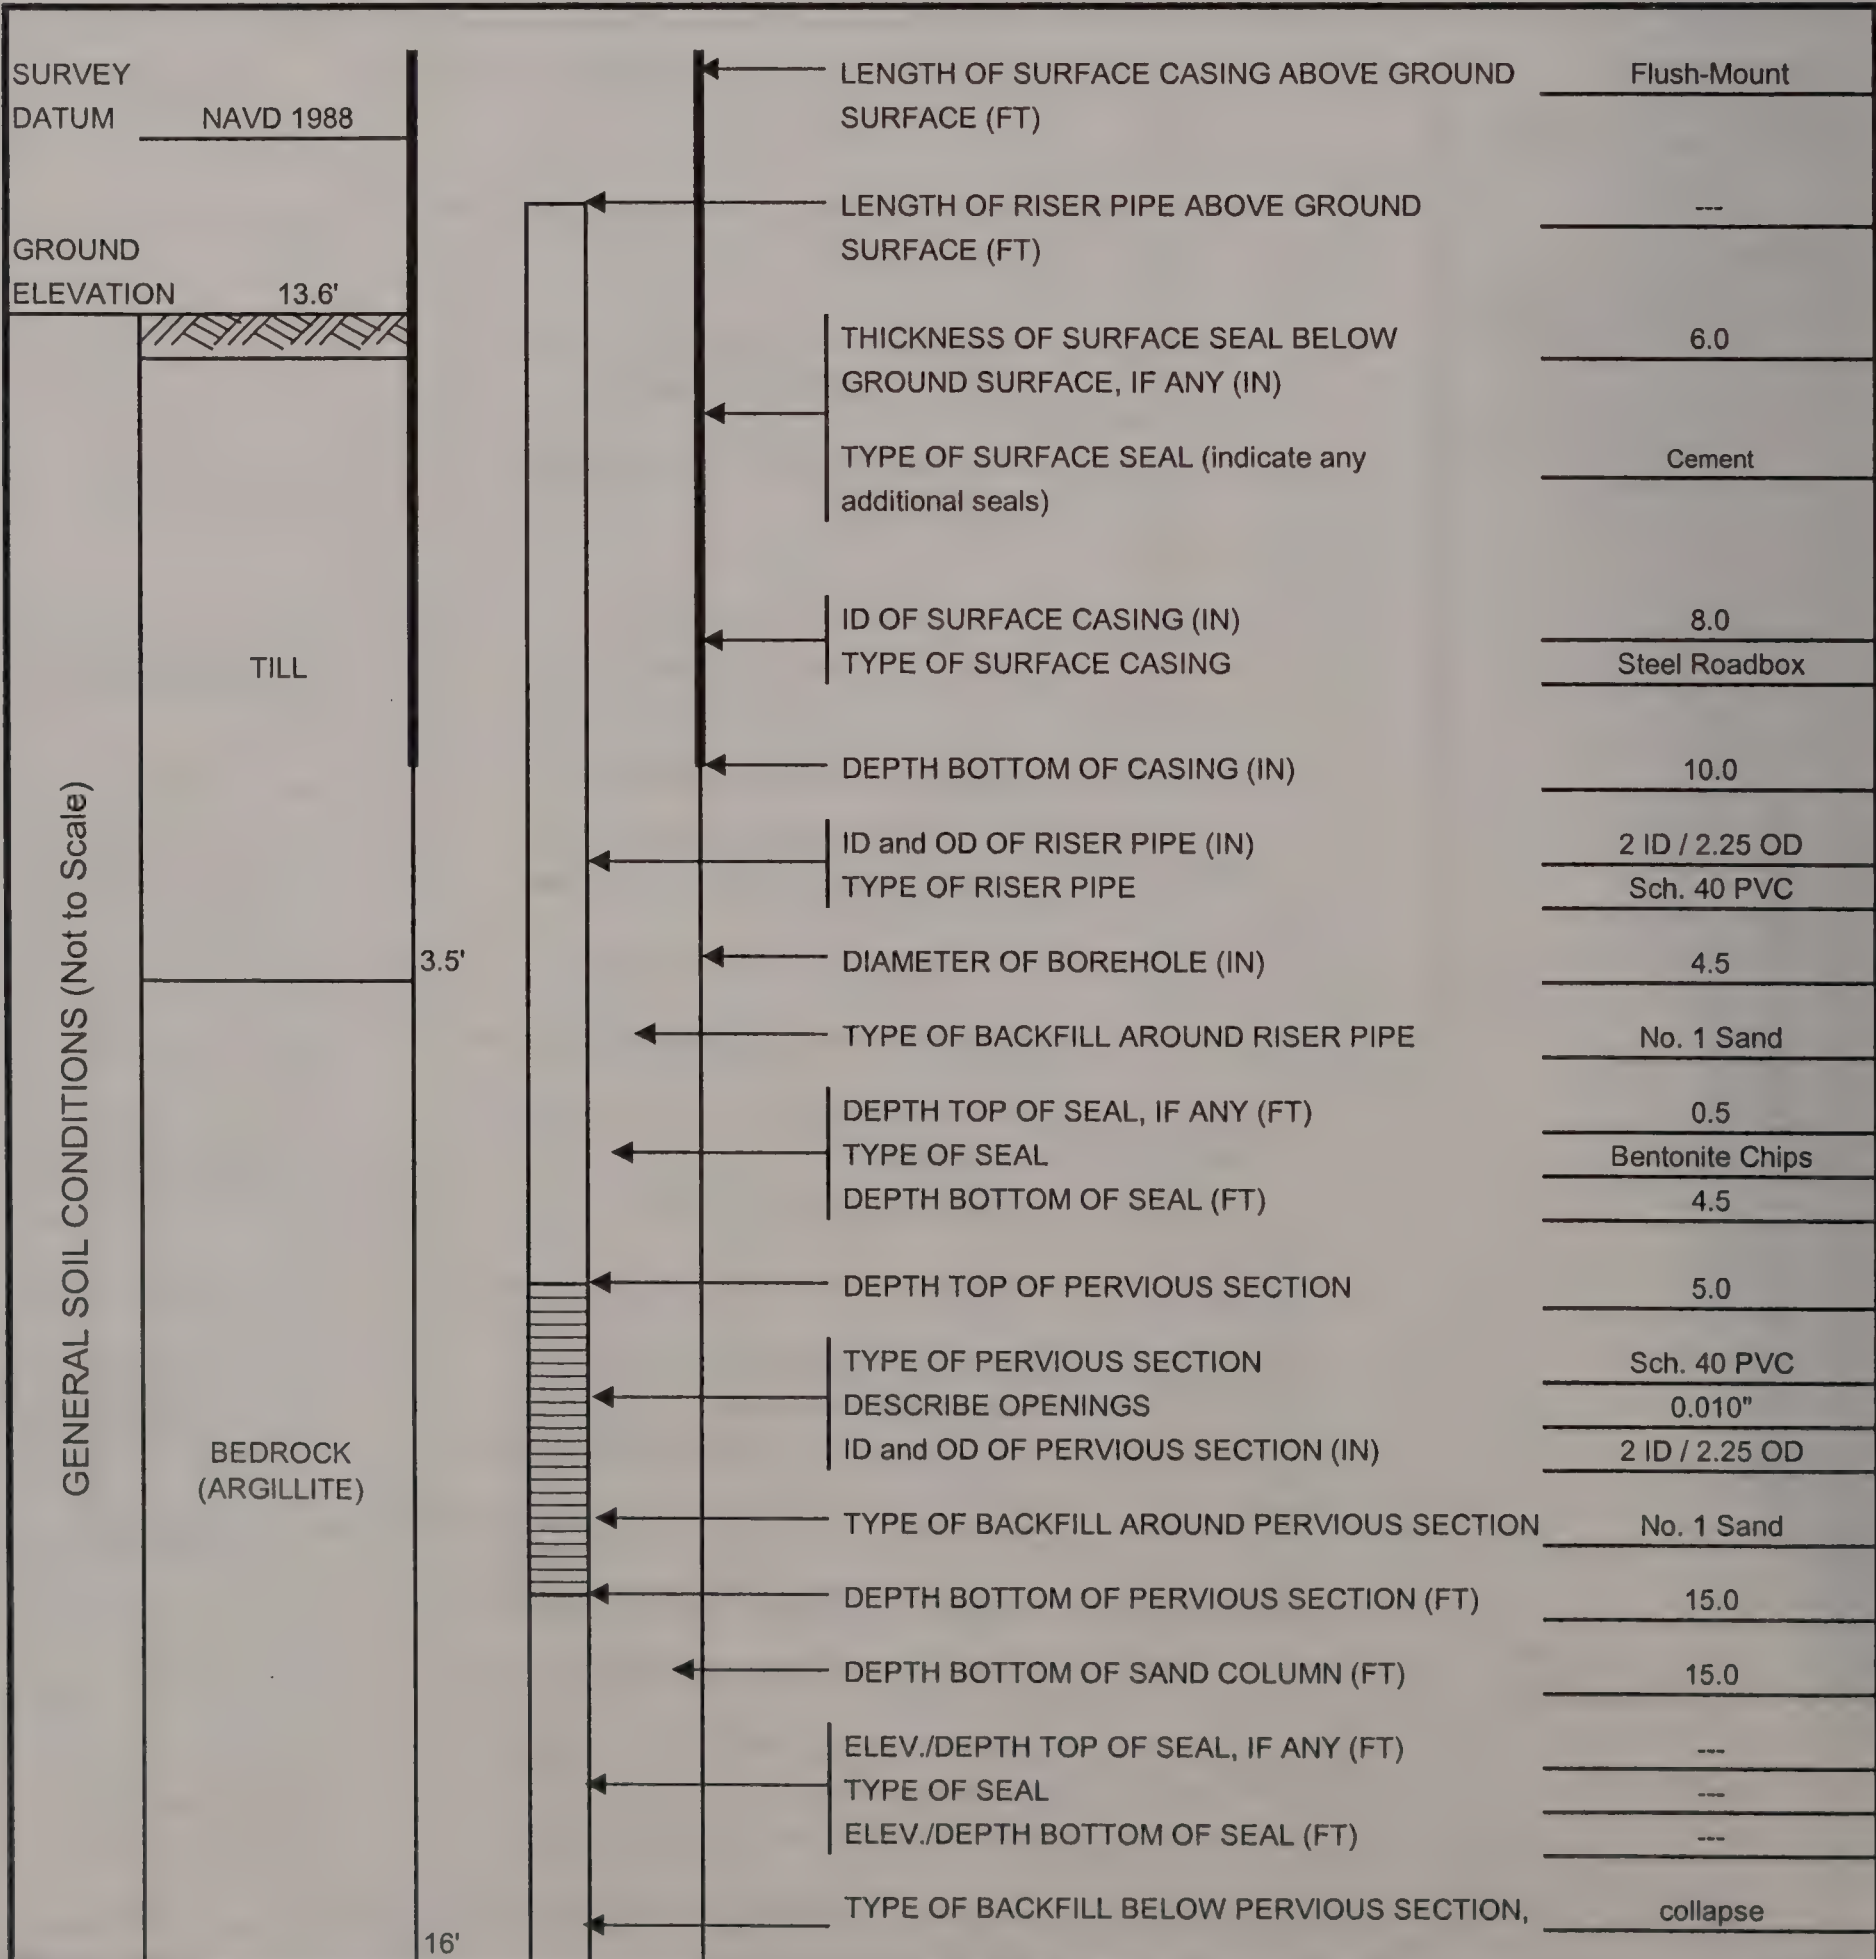
GROUNDWATER OBSERVATION WELL REPORT				MW116	
Project 50 Tufts Street				PG. 1 OF 1	
Location Somerville, MA				Boring No. B116	
Client UniFirst Corporation				Location South side of	
Contractor GeoSearch		Driller Rodney Dean		Capuano School	
Inspected by Heather Ballantyne		Date Started 3/10/07		Project No. 045162	
Checked by		Date Completed 3/10/07
